National Transportation Safety Board

## **Airplane Performance**

**Air Sunshine Flight 527, Cessna 402C, N314AB, Treasure Cay, Bahamas**

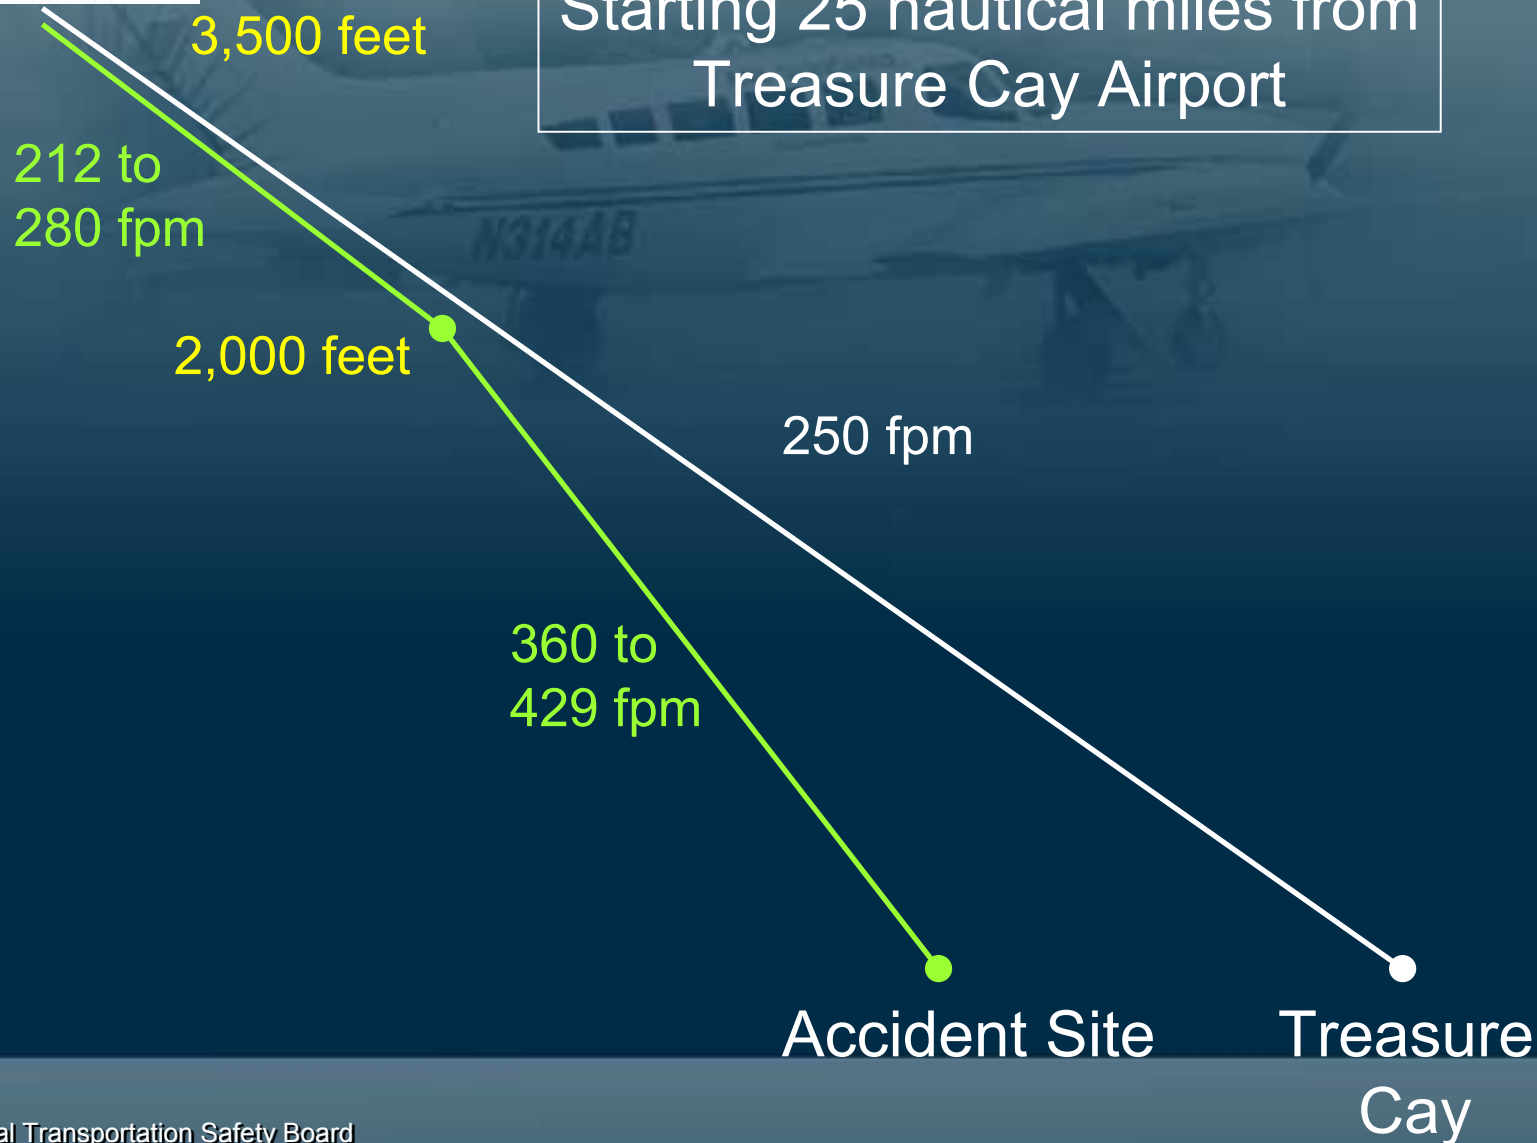
# Average Descent Rates Starting 25 nautical miles from Treasure Cay Airport

- Average descent rate of about 250 fpm would have resulted in airplane reaching Treasure Cay.
- Average descent rate of accident airplane below 2,000 feet was between 360 and 429 fpm.
- Maximum flight performance was not maintained because of operational factors.
